INDIVIDUAL PROPERTY/DISTRICT  
MARYLAND HISTORICAL TRUST  
INTERNAL NR-ELIGIBILITY REVIEW FORM

Property/District Name: Amos Alexander (Beers) Farm Survey Number: CE-300

Project: Restoration of Springhouse Agency: DNR/non profit organ.

Inventory Numbers: CE-300, CE-300-B, CE-300-C  
Beers Complex  
Cecil County, MD  
C. Mazurek  
June 1998  
Section 7.1

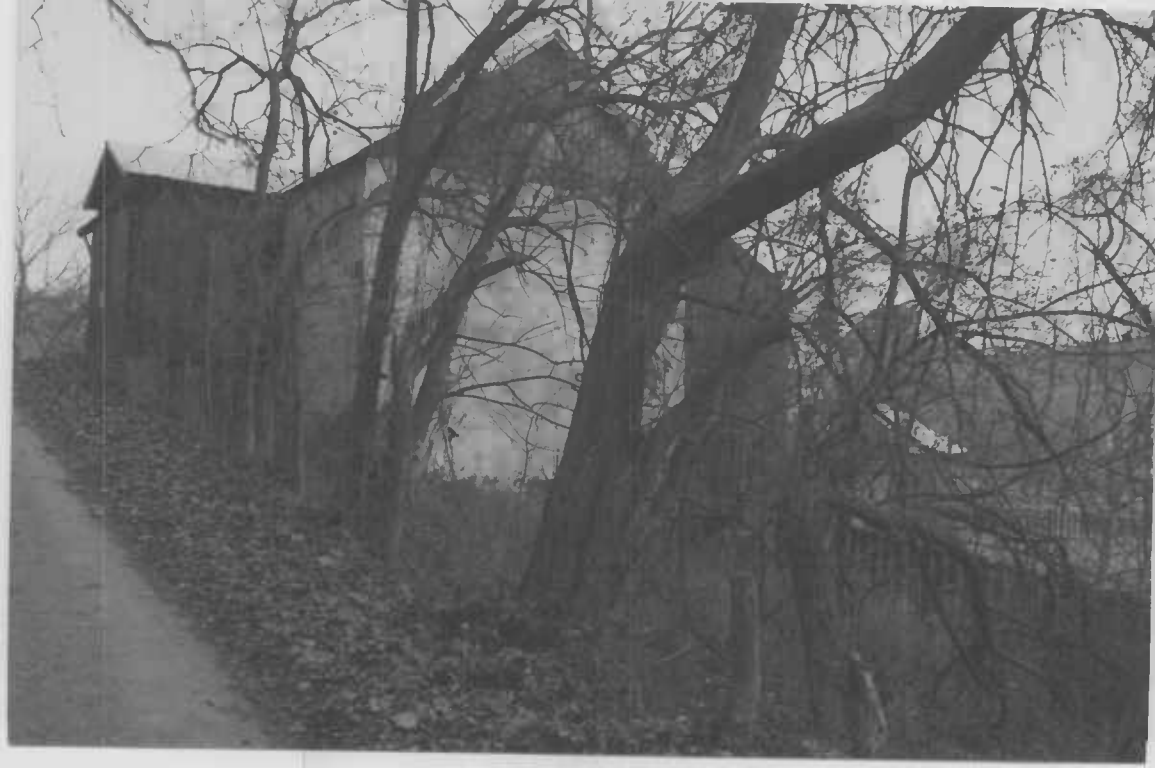
14.a

BEERS BARN, FAIR HILL N.R.M.A.  
CECIL COUNTY, MD

N.W. ELEVATION

At least the 1826 Barn, if not this entire complex, is eligible for the National Register, probably in company with its near twin across Big Elk Creek, the Finley Barn (DNR-4/CE-301-A). The complex is occupied and appears to be prosperous and in good repair. Routine maintenance and upkeep should be carried out with an eye toward a return to an original appearance.

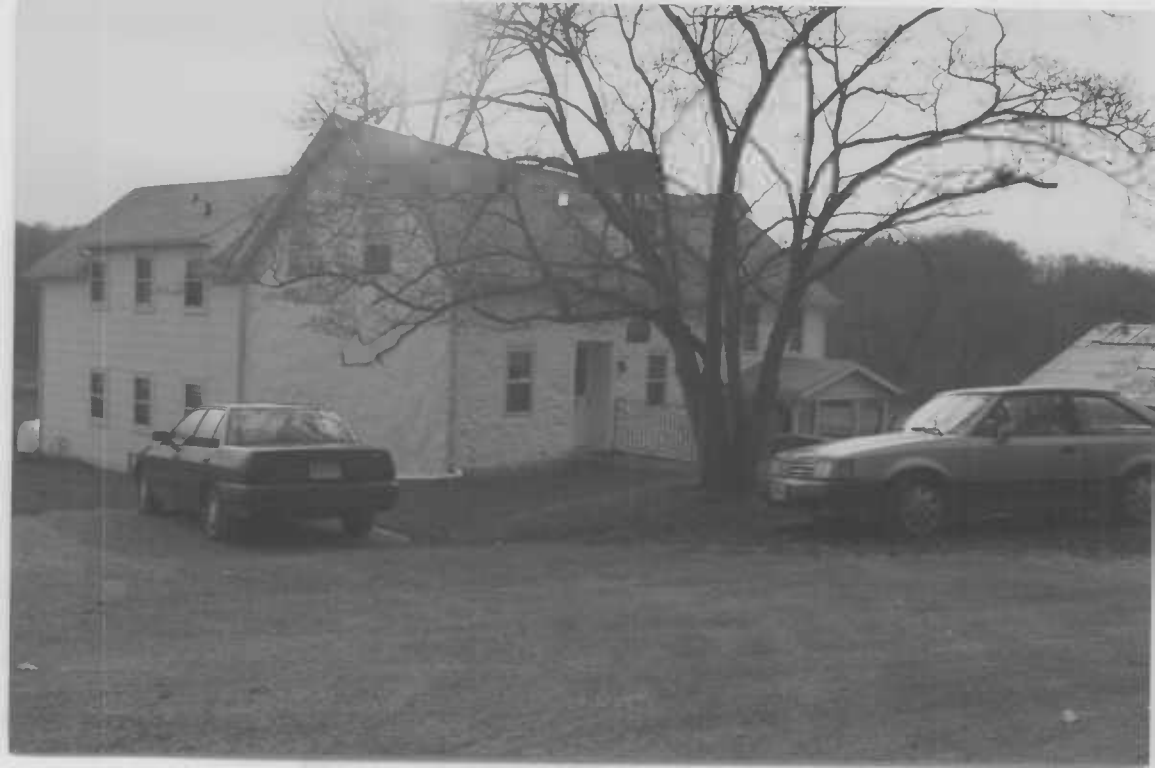
CE-300

The Beers house (CE-300) is a rental property by the Department of Natural Resources and is in excellent condition. Since the last survey was completed in 1978-1979 the exterior structure has remained the same, with the exception of the front porch posts. The old wood posts, the bottom half a squared shape and the upper half a rounded shape with a doric capital, have been replaced with completely squared wood posts with straight brackets at the top.

BEERS HOUSE, FAIR HILL N.R. M.A.  
CECIL COUNTY, MD

DEPT. OF NATURAL RESOURCES  
N.E. ELEVATION

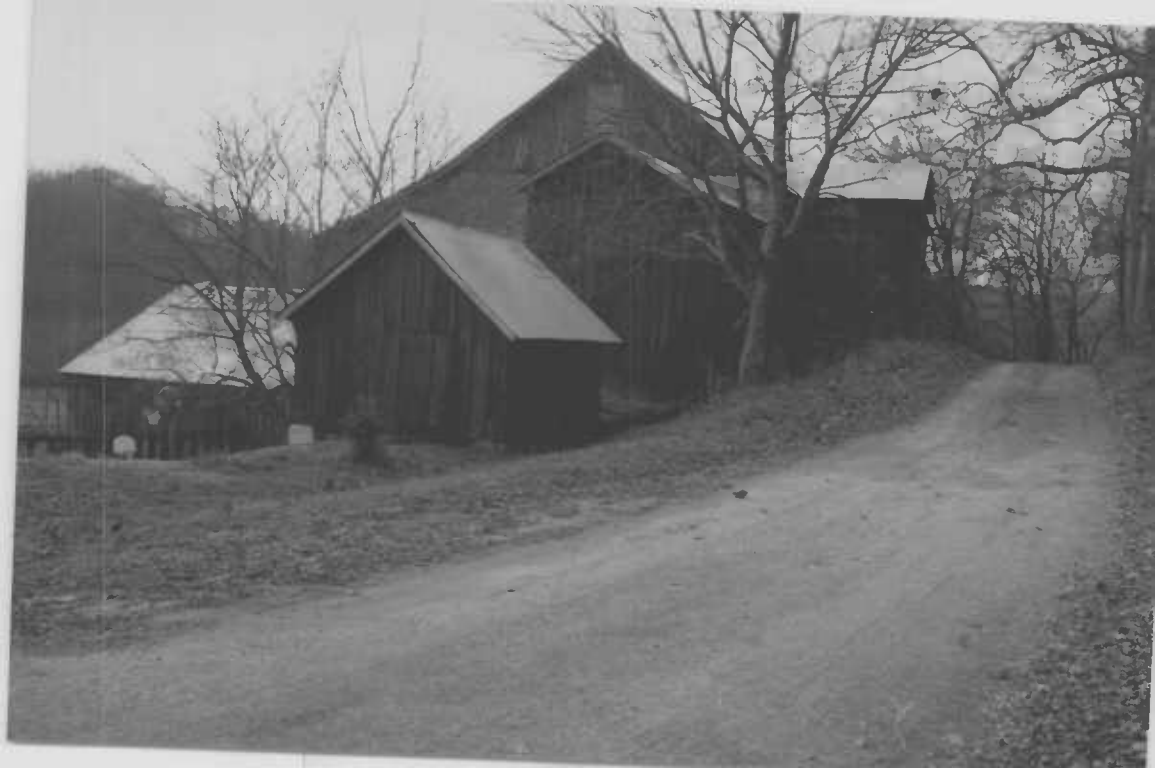
14.a

BEERS BARN, FAIR HILL N.R.M.A.

EAST ELEVATION

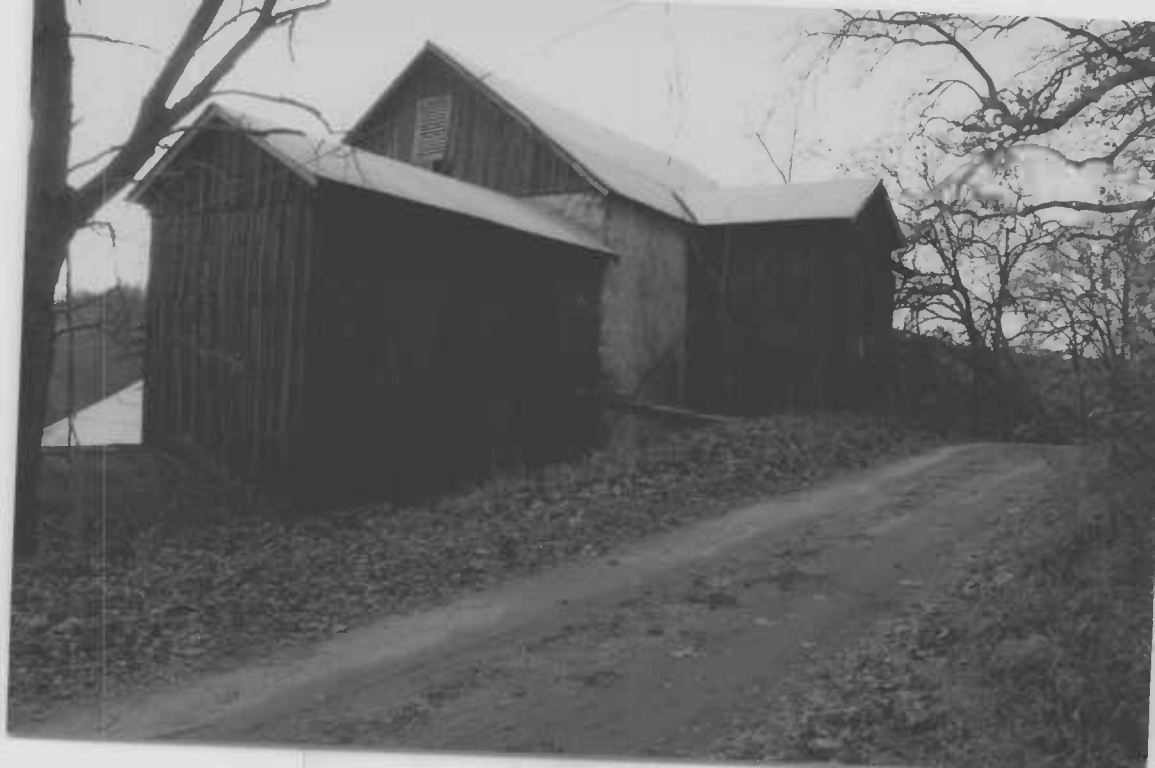
14.a

BEERS COMPOUND, BARN, FAIR HILL N.R.M.A.

N.E. ELEVATION

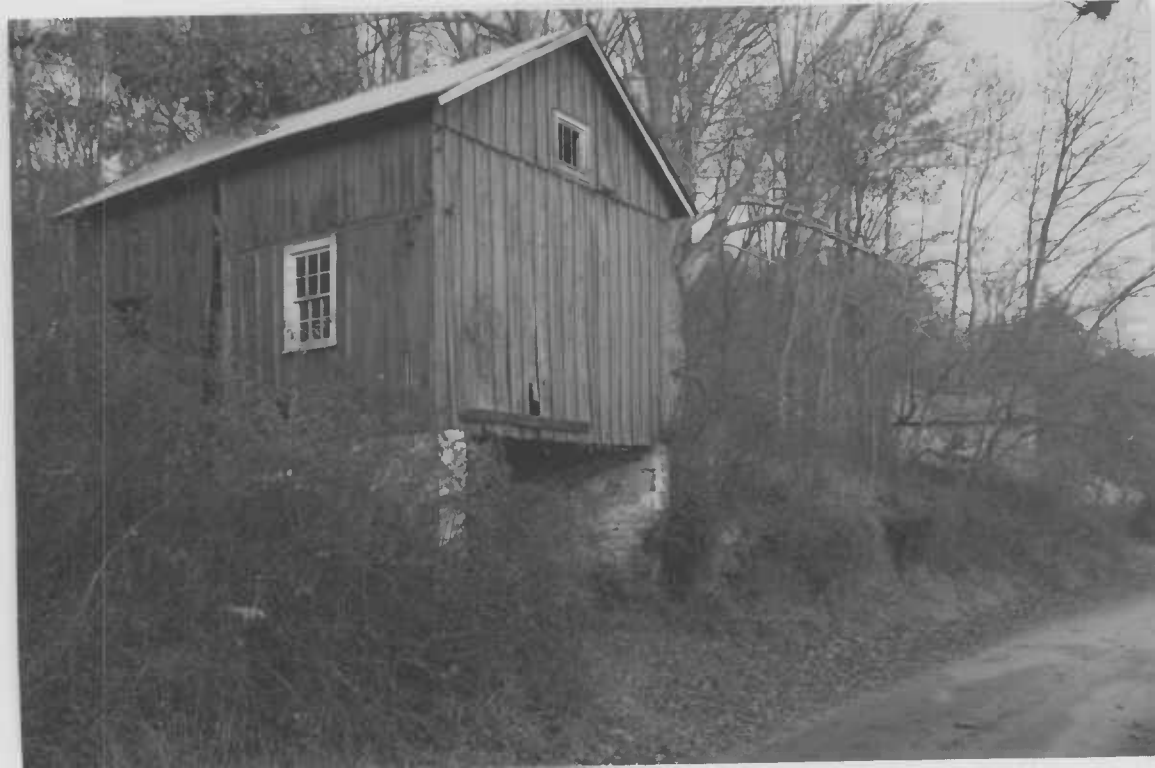
14.C

The Beers Stable and Hayloft/Garage (CE-300-C) are kept in good condition, with no apparent alterations to the exterior of the structures. As with the Smokehouse, vegetation near the Hayloft/Garage has been allowed to grow too close to the foundation.

BEERS COMPOUND HAY LOFT, FAIR HILL N.R.M.A.  
CECIL COUNTY, MD

DEPT. OF NATURAL RESOURCES  
S.W. ELEVATION

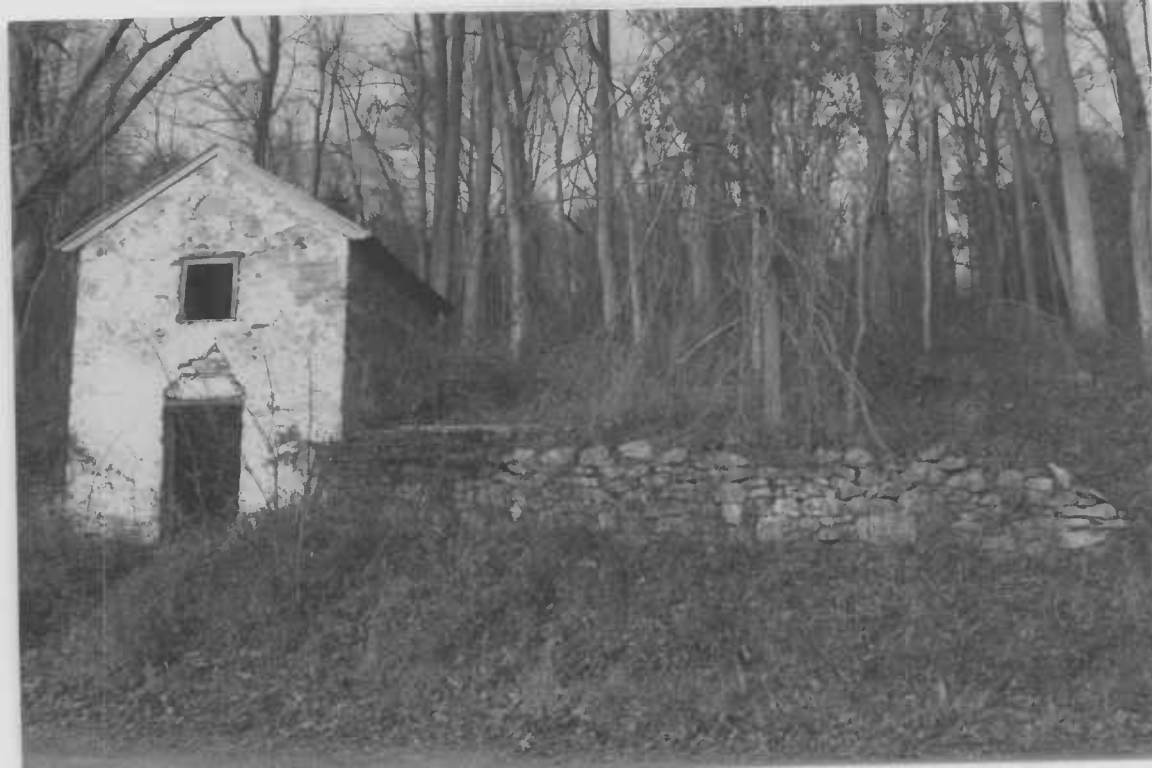
14.d

The Beers Smokehouse (CE-300-B) has lost it's front batten door with tapered iron strap hinges, however it may still be located on the property somewhere. The gable roof is intact and keeps the rain out of the understructure. Some of the vegetation around the Smokehouse has been allowed to grow too close to the foundation and stone retaining wall, but it has not yet led to deterioration.

BEERS COMPOUND SMOKEHOUSE, FAIR HILL N.R.M.A.  
CECIL COUNTY, MD

DEPT. OF NATURAL RESOURCES  
S.E. ELEVATION

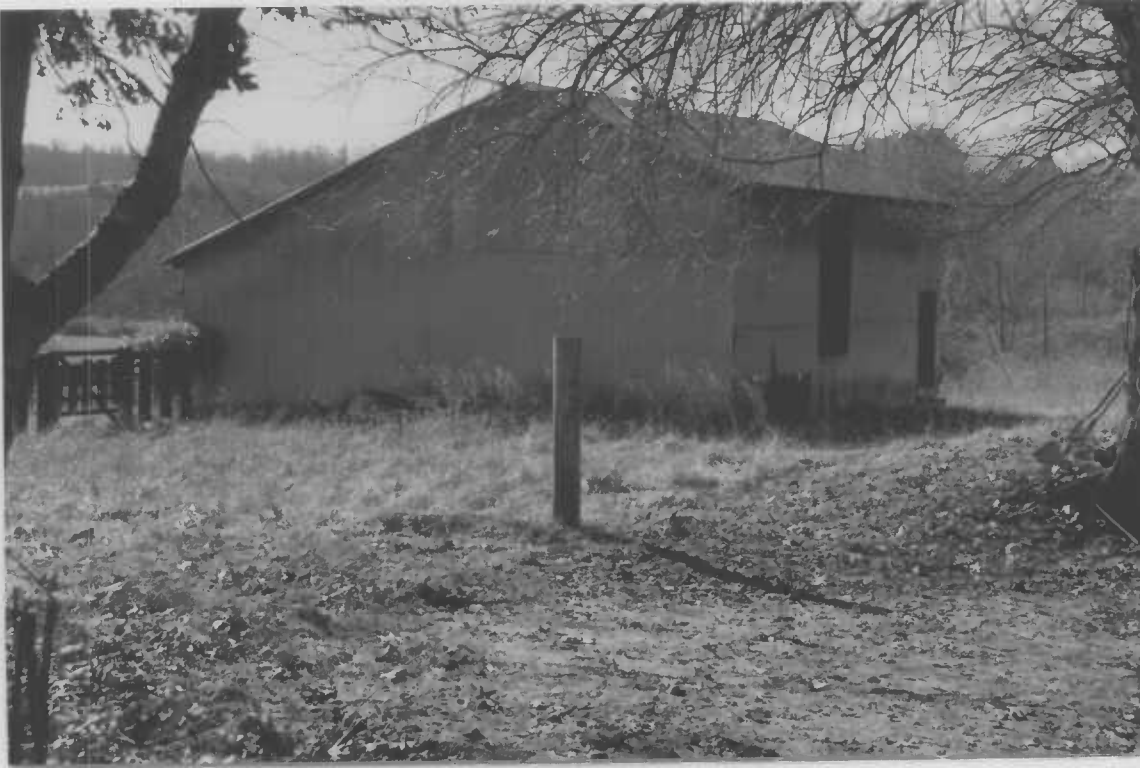
14.F

BARN

NORTH EAST ELEVATION

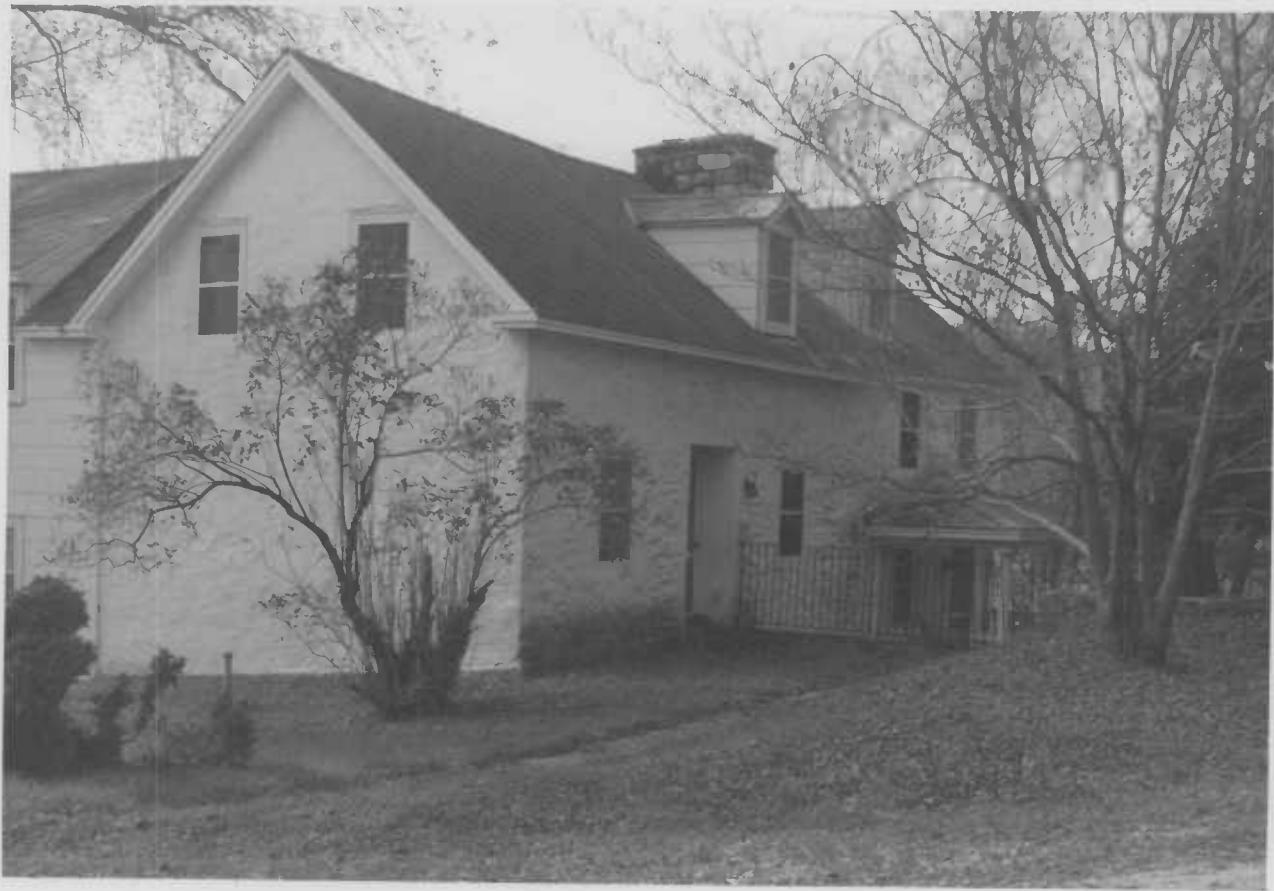
Beers House

Northeast Elevation
